# Giovanni Grancino

## Violoncello Milano 1696

Restoration 2013-2014  
Julia van der Waerden

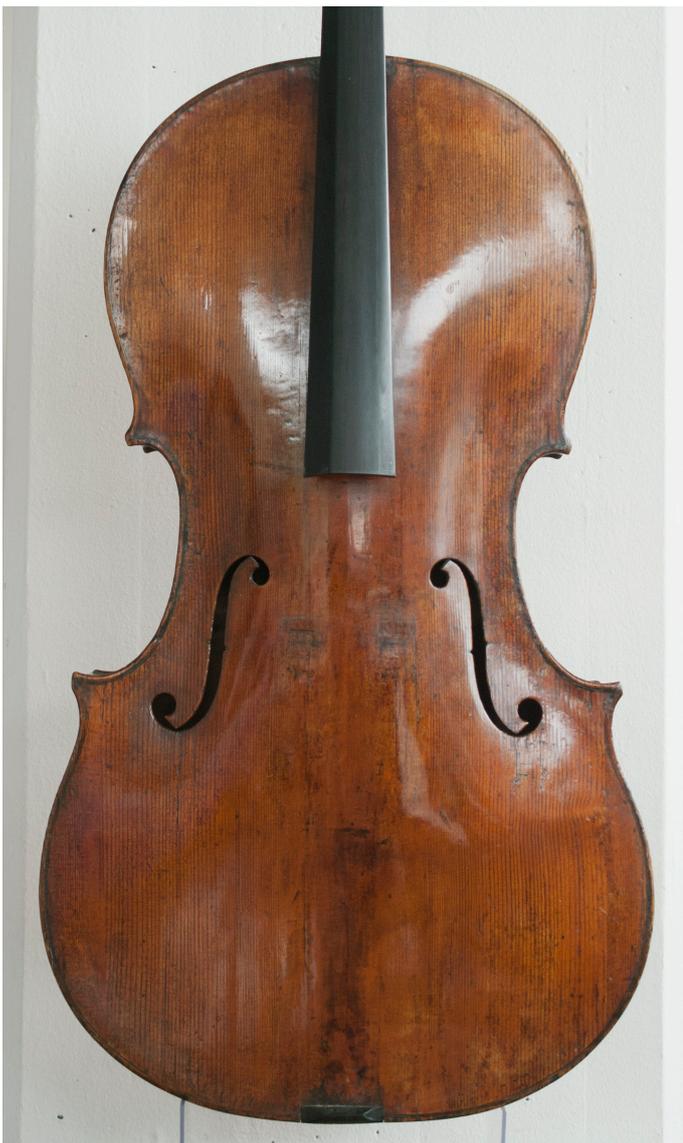
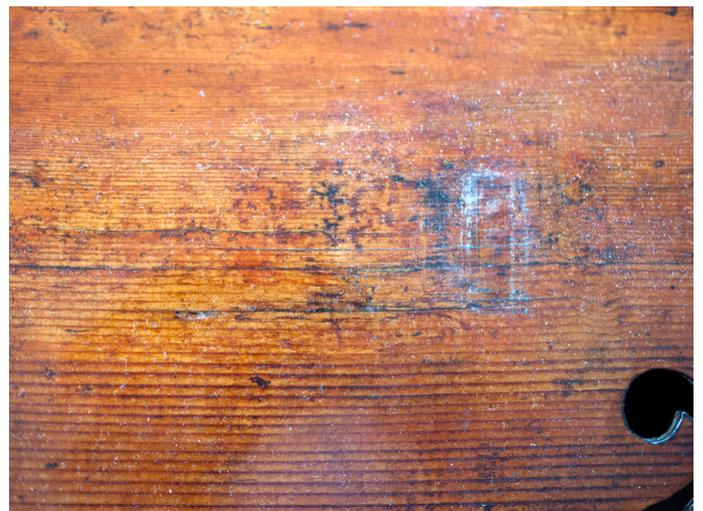
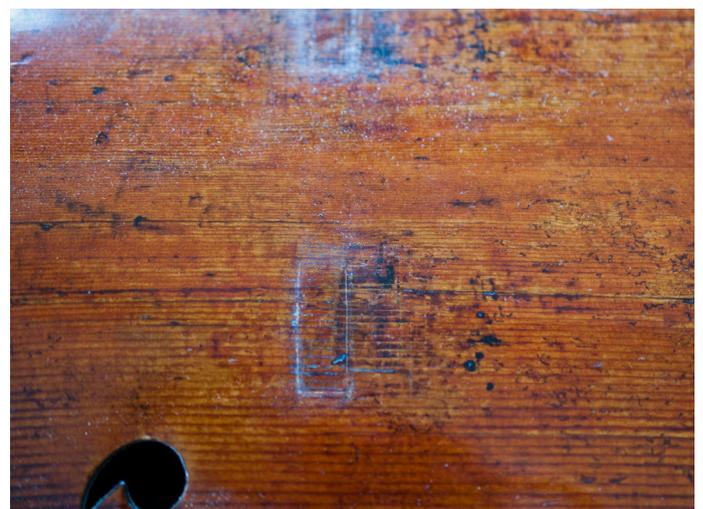
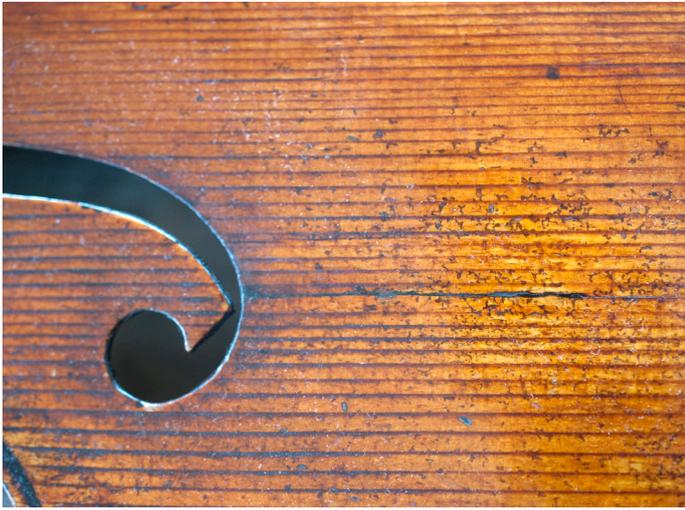
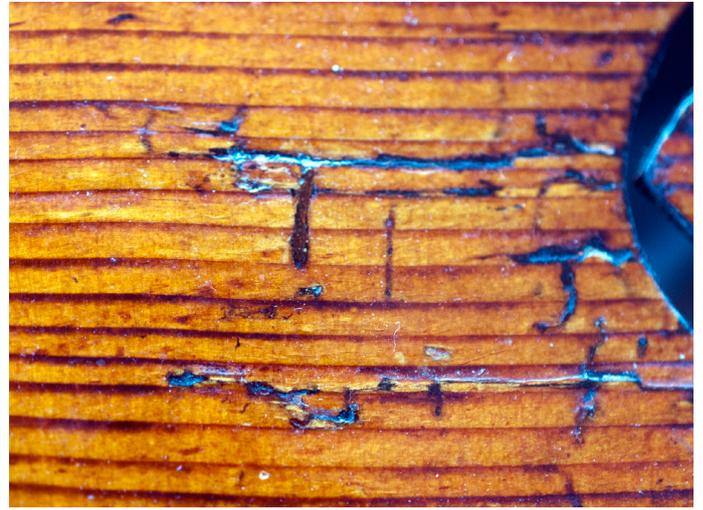
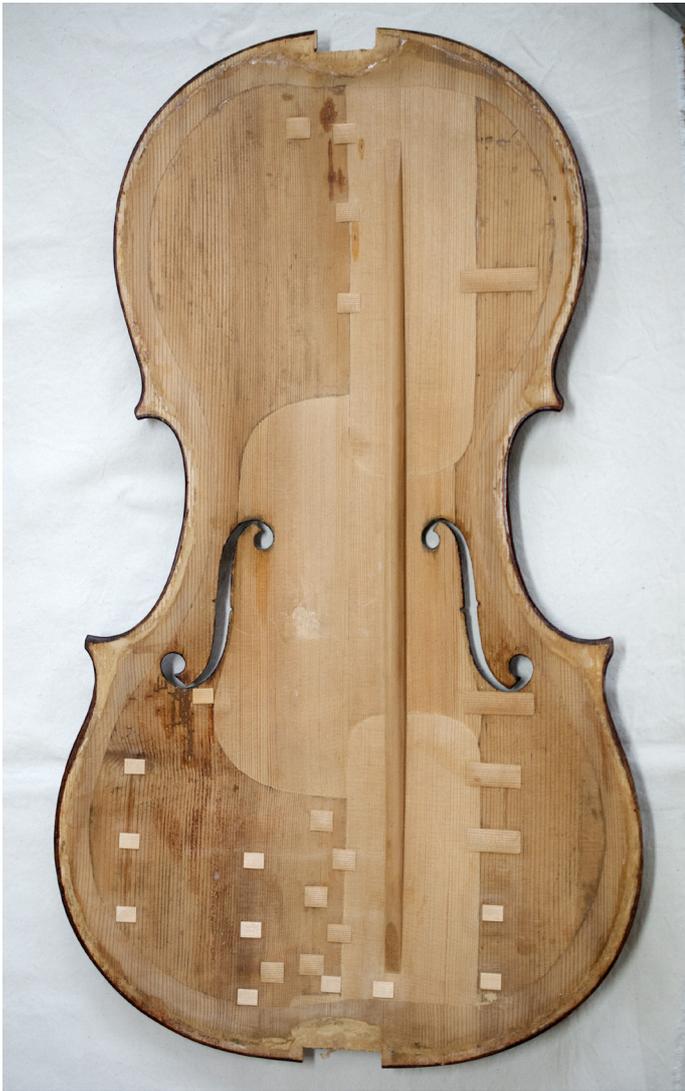
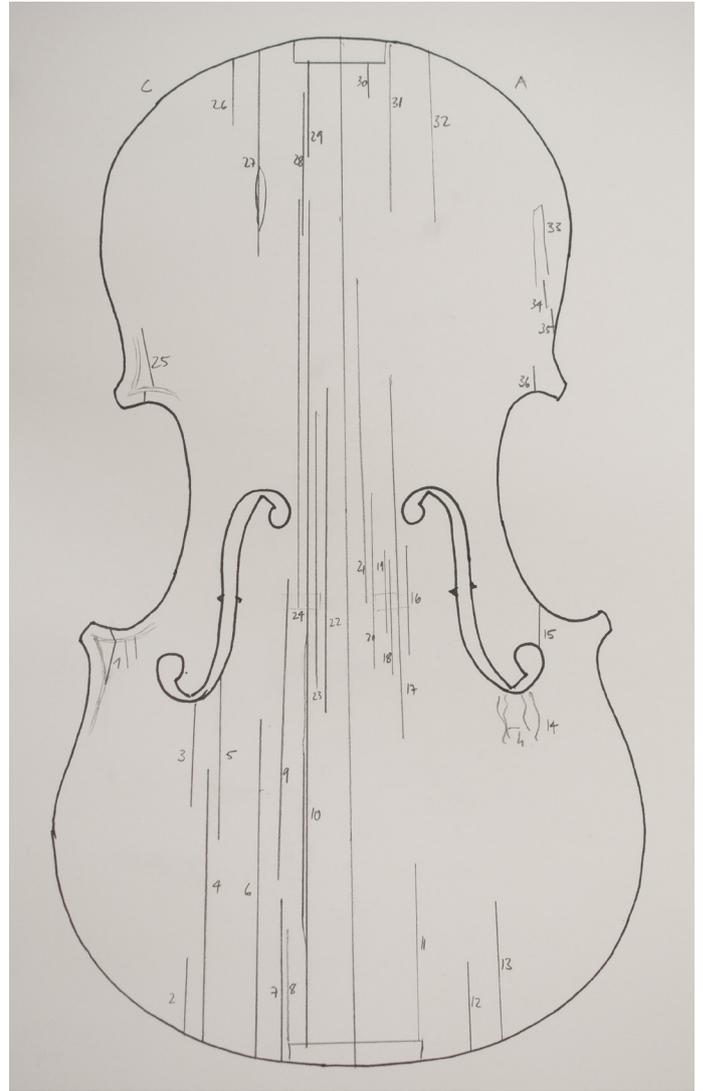
after opening the cello, three big patches cover most the bassbar area. Probably there has been a lot of worm damage underneath an old bassbar.

to make an estimate, one has to count all the cracks and damaged areas and evaluate them. The thickness without the patches was in big areas only around 1 Millimeter.

As the top is so fragile during the whole process one needs a plaster cast to secure it. Here the cello is ready to get a cast made for it.

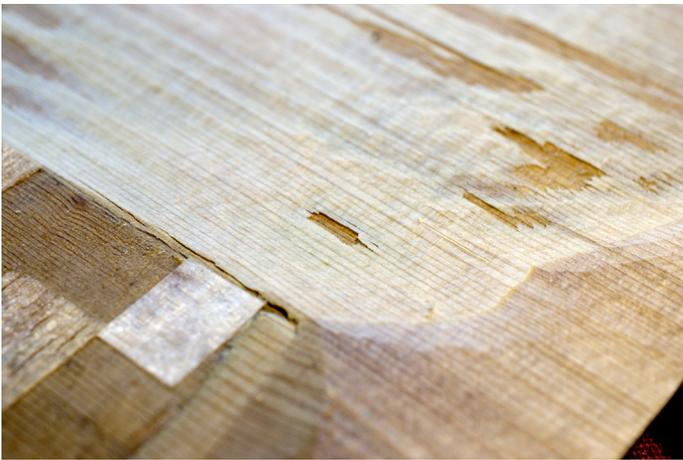
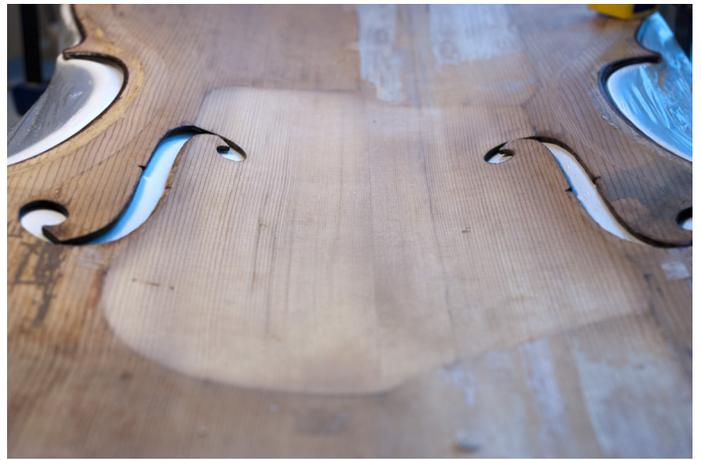
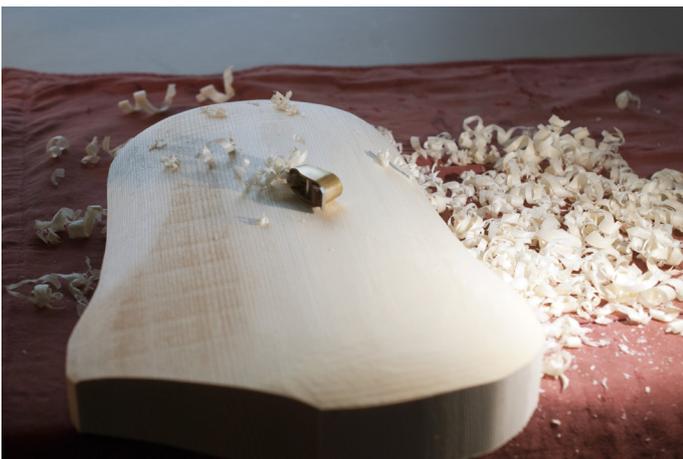
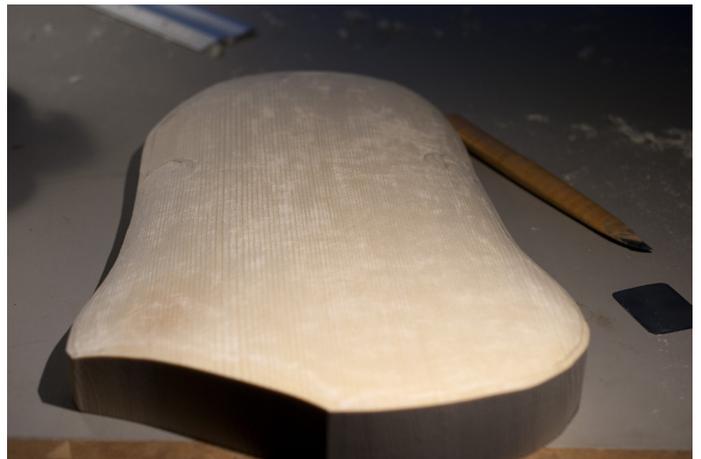
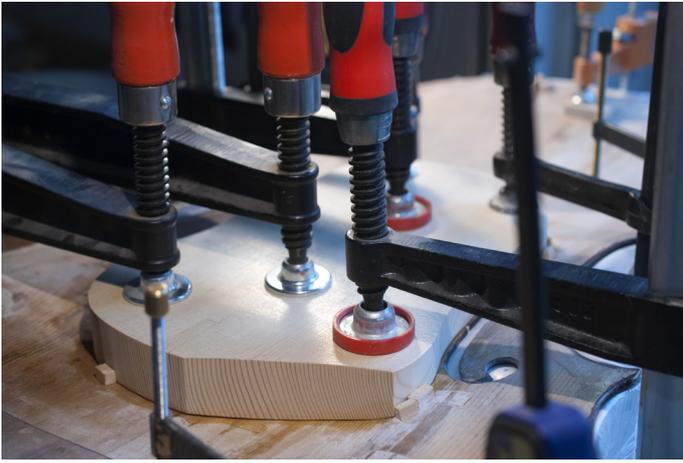
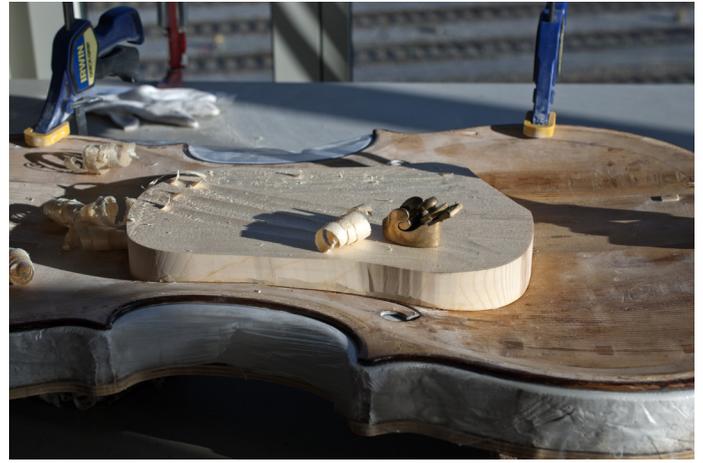
The old patches are getting removed, showing a gap, partially filled with dried glue, but often just with plain air and dirt. This shows that the cello really is in need of a replacement of all of the old repairs. When all the cracks are glued and the area is clean and even, a new piece of spruce is fit in place. The grain should match the original and it is crucial that the wood is of the best quality and aged well. Therefore I have a big stock of old, different kind of wood, where I can find the best piece.

After the patch fits perfectly and even all over the breast area - to make sure this is the case, one uses chalk and very fine scapers - the still thick piece gets glued with hot bone glue. Only after drying for several days, the clamps get removed and the piece is thinned down with a plane. I leave it a little too thick for a long time to make sure, the arching stays in the new position. Now the two other patches need to be done in the same manner.

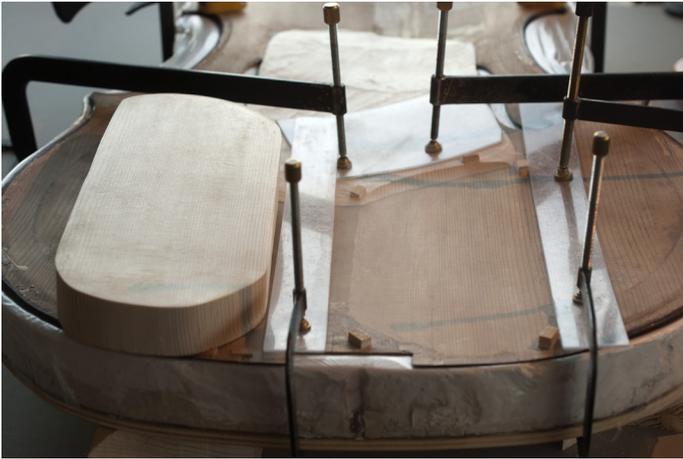
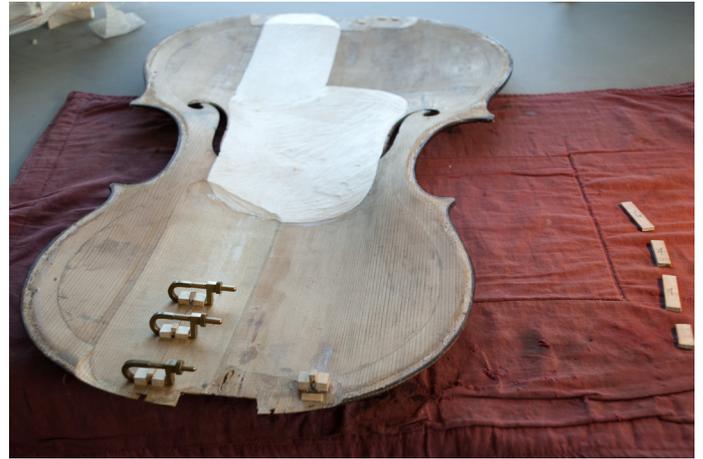
These two pictures show the area next to the lower saddle before and after the restoration. The cracks are glued, the patch is finished and invisible from the outside.

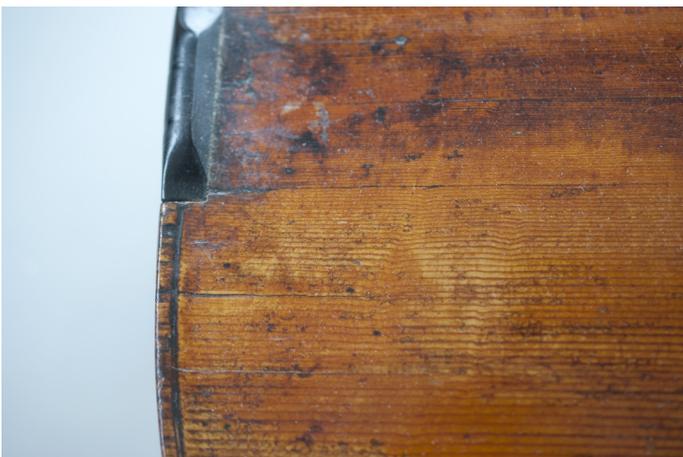
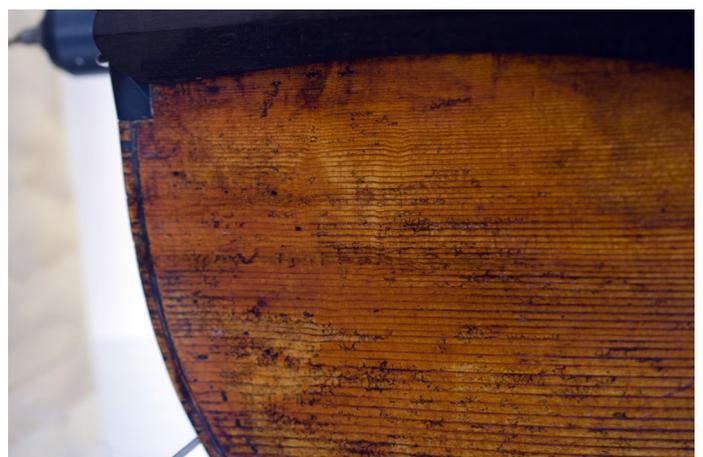
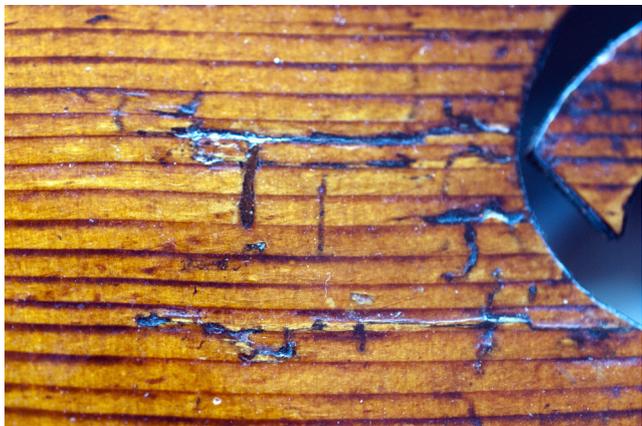
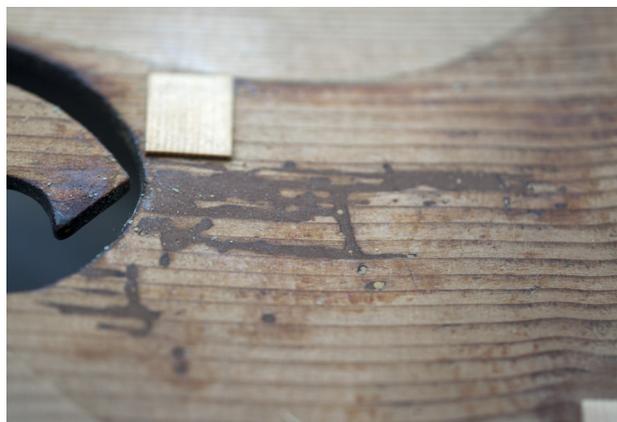
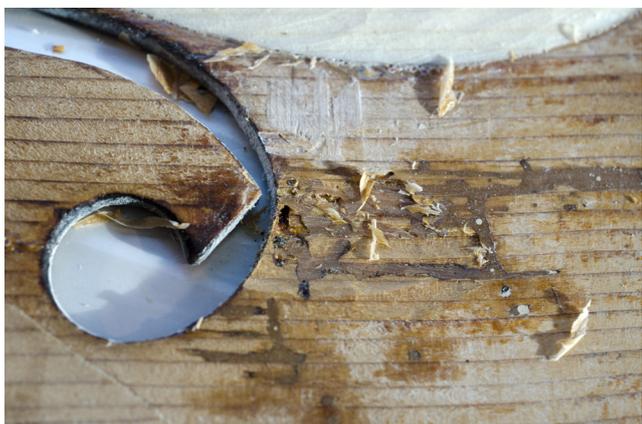
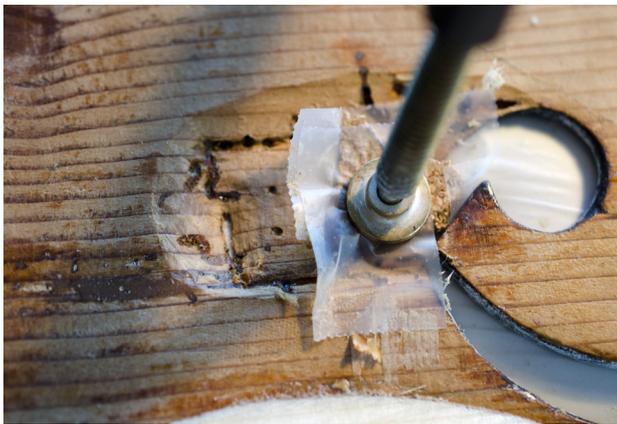
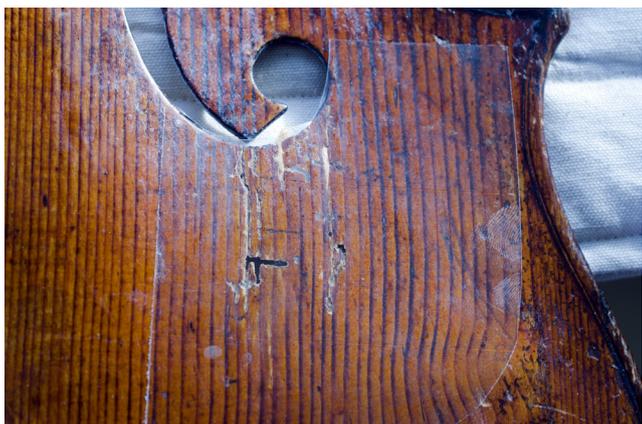
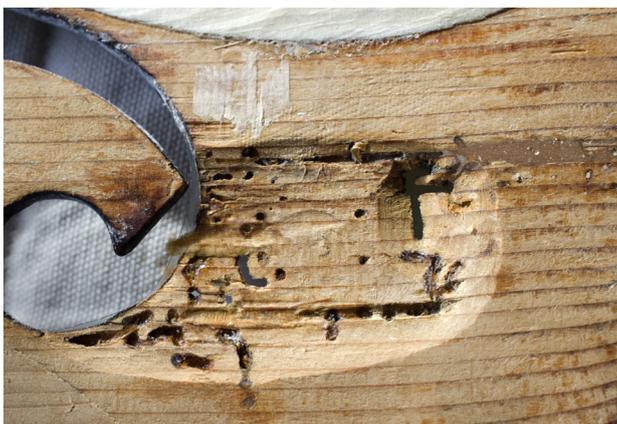
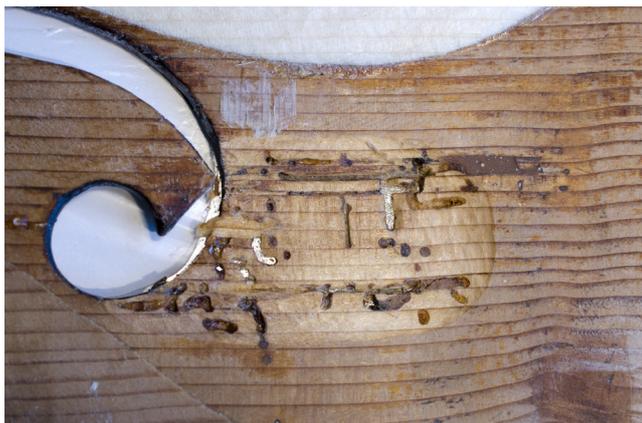
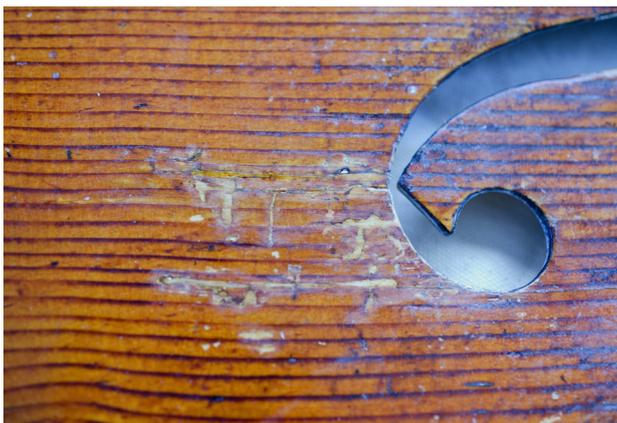
Now there remains the difficult task of the very damaged area under the F-hole.

Soon it is obvious, that it is impossible to remove the filling of the wormholes with any solvent. All of it needs to be removed manually, and making a new patch was inevitable. Also because this area moves a lot and would easily rattle, if the pieces are not safely fit.

The damage is visible from the outside and to make it look as good as possible I take little shavings of the removed original wood to cover the missing spots. As the original is very thin, I use a plastic foil to hold it together.

Only when all is even and stable I remove the plastic and fit a patch.

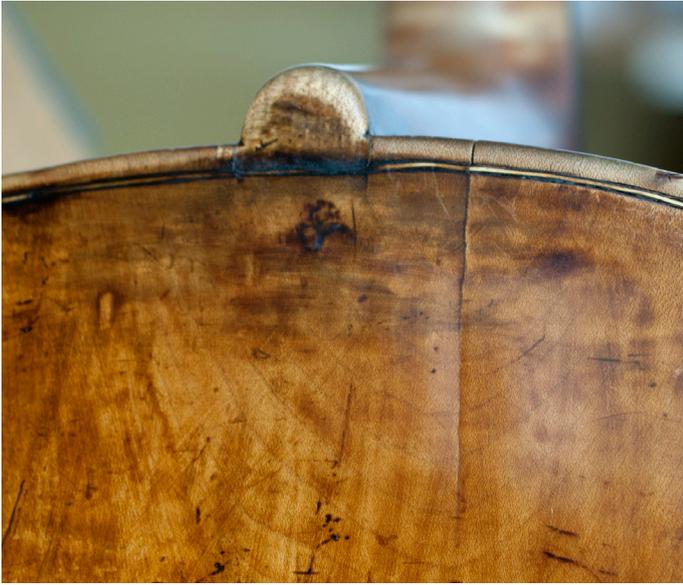
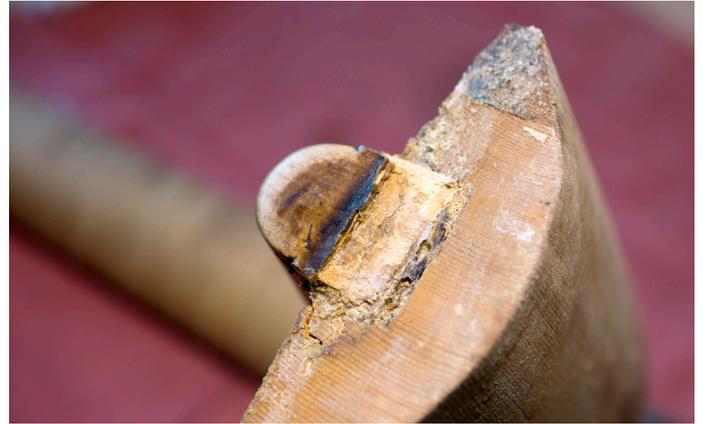
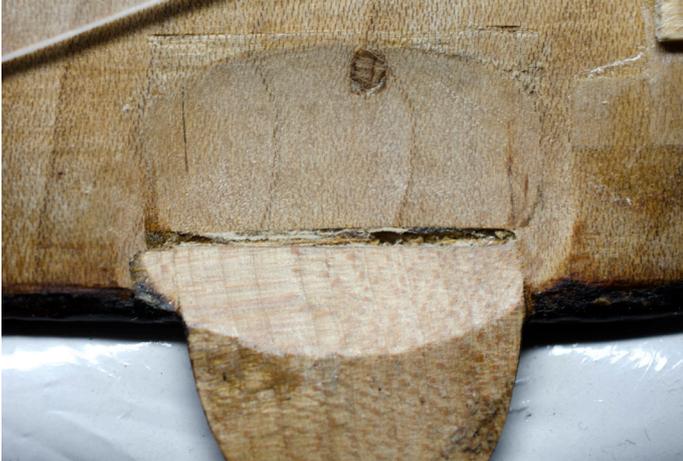
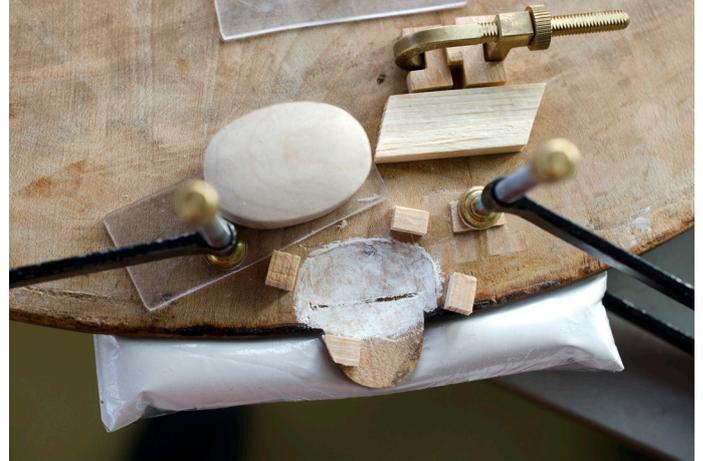
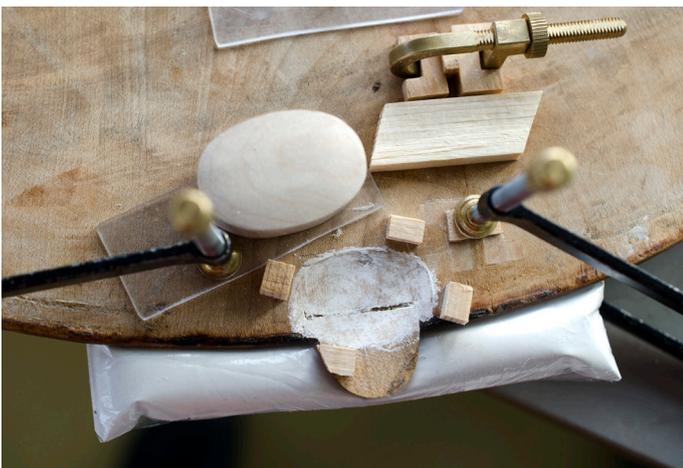
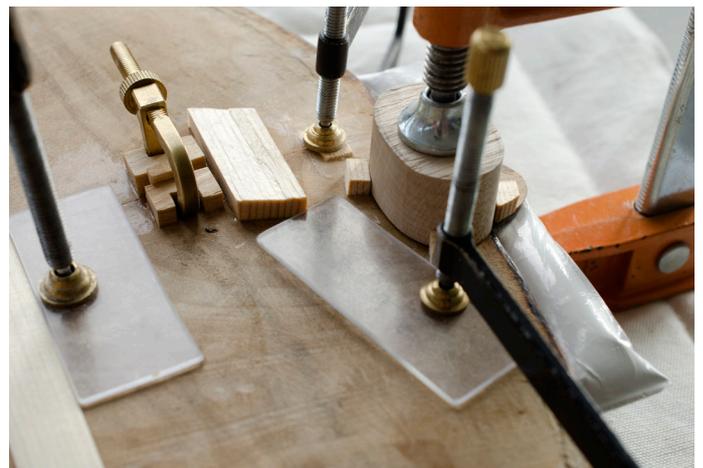
The arching needs to be stabilized since it was very distorted in the area around the upper and the lower block. Therefore I make some studs, 10 mm wide and around 150 mm long.

The crack next to the button was opening very much, especially with the correction of the arching it had even more tension on it. So I have to find a balance of how much I can actually correct the arching and how much pressure I can use to glue the crack, so it still would be stable in the future.

The work on the button is clear. It is glued very badly and needs a patch to hold better to the back. There is a big pressure on this part of the instrument and it needs to fit perfectly.

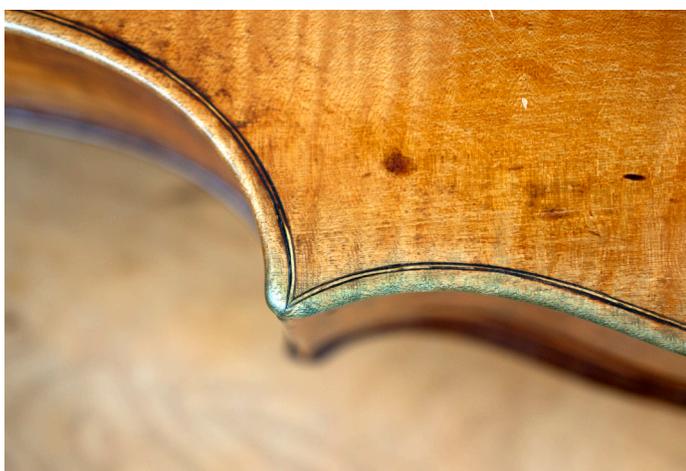
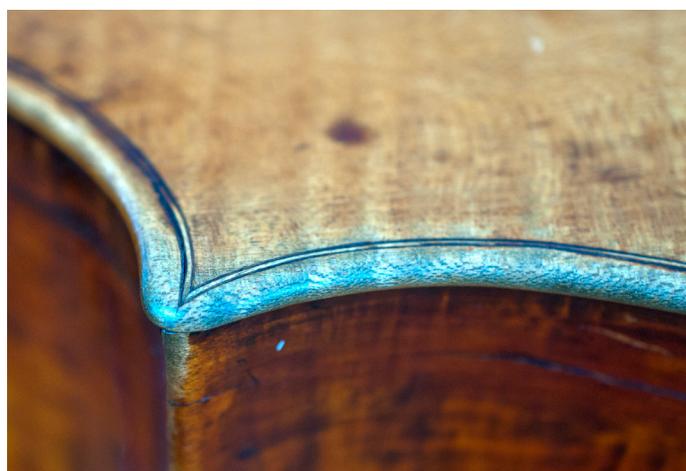
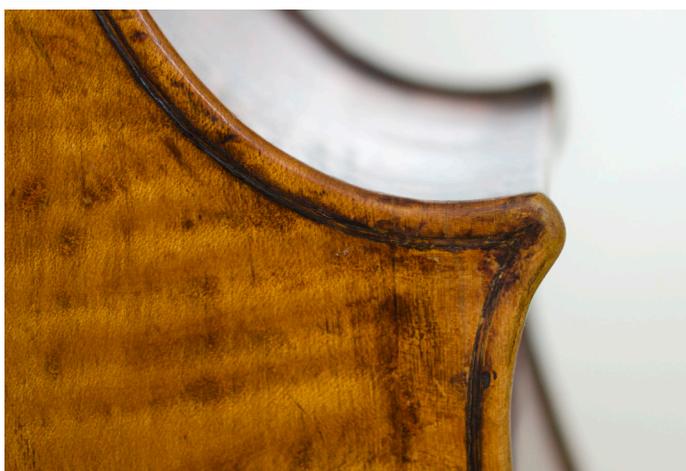
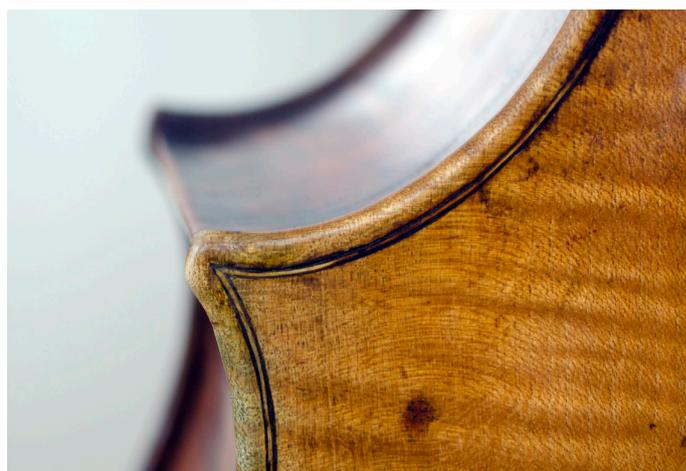
corners before and after the replacement

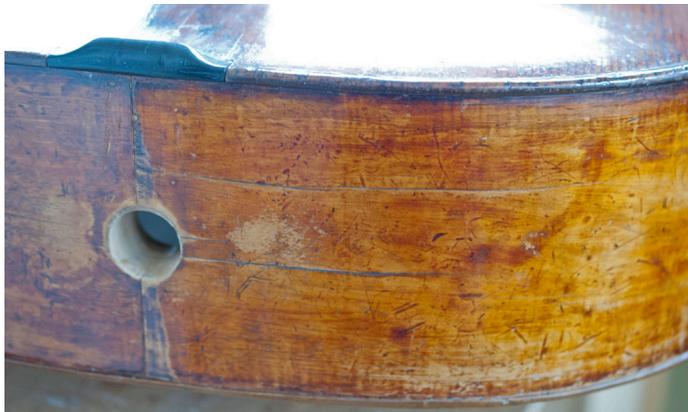
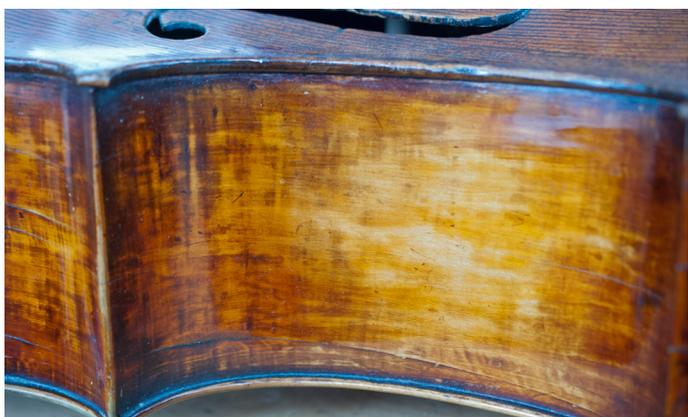
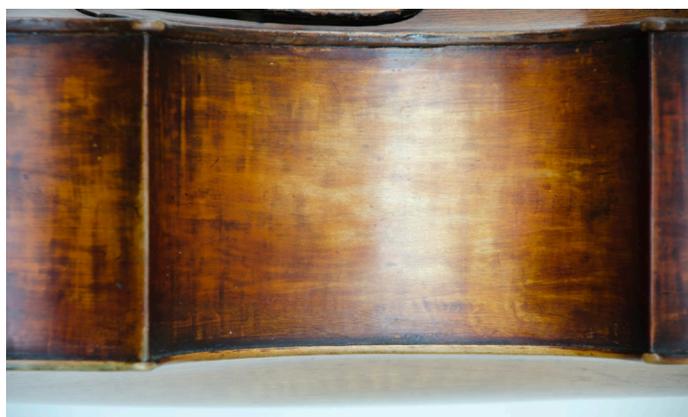
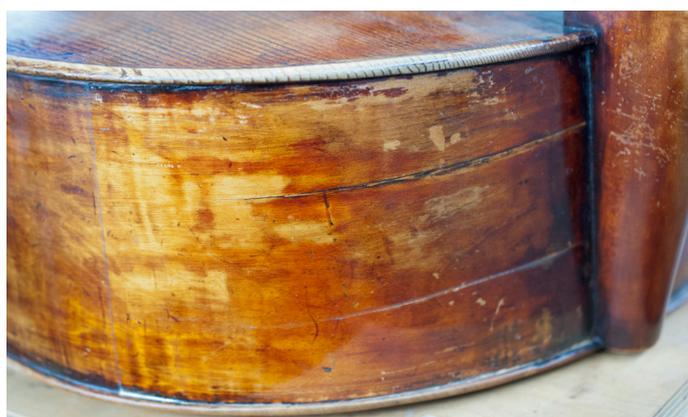
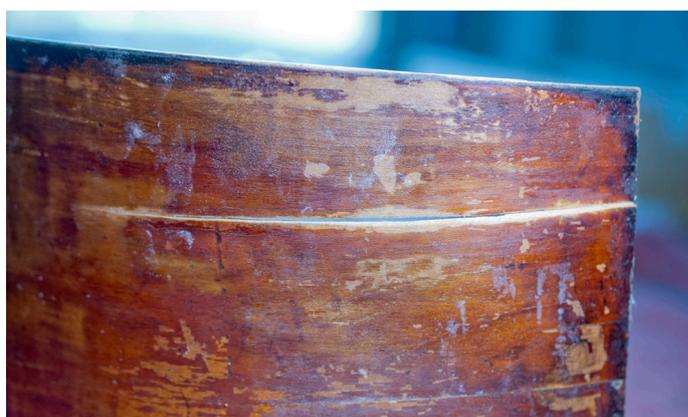
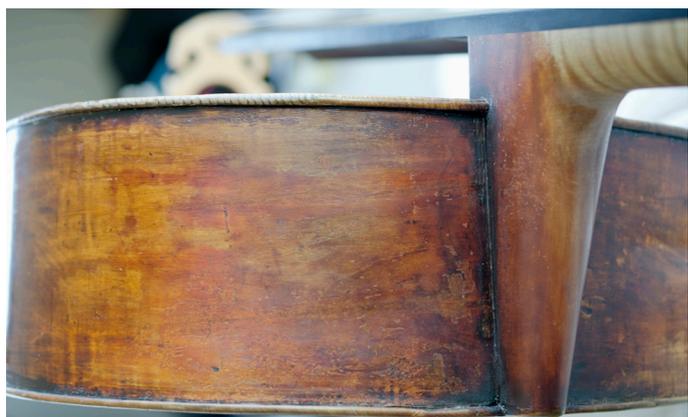
All the cracks need to be cleaned and glued properly. Often they are open, dirty and glued uneven. The old glue is hard to remove, because it is not the bone glue we usually use. Inside the cracks are held together with thick wooden patches, which are usually bad for the sound of an instrument.

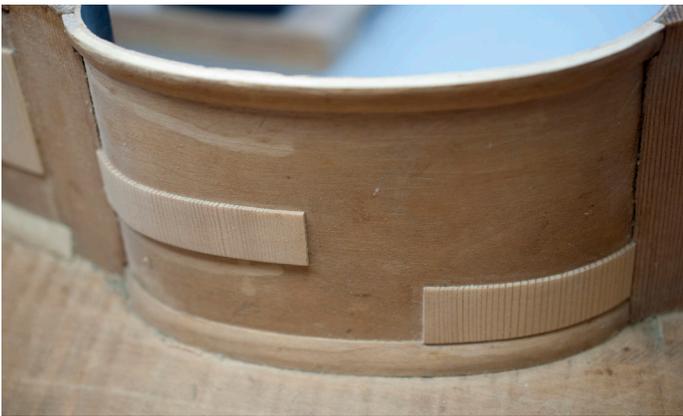
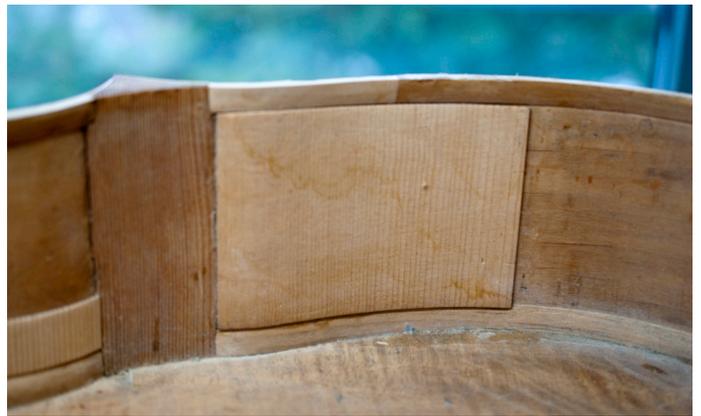
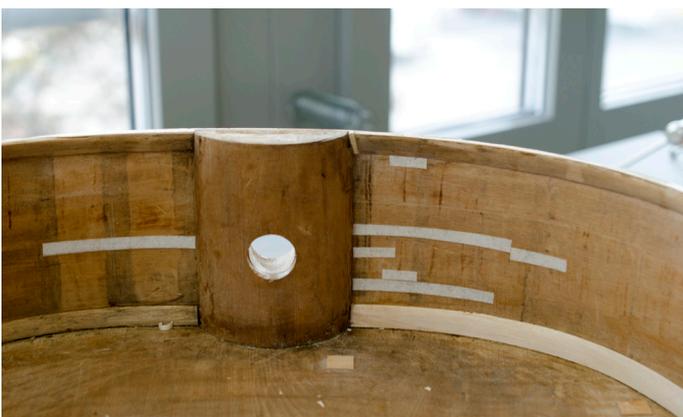
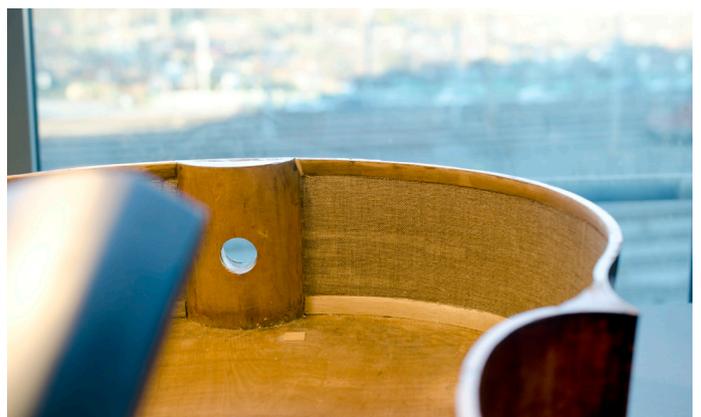
Some pictures of the inside, first the old patches, then the newly glued parchment and linen.

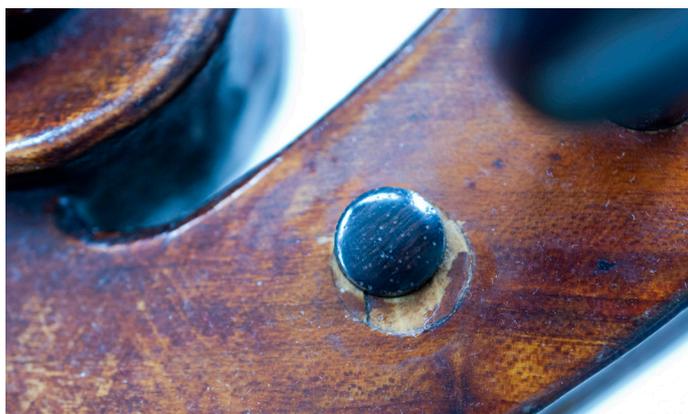
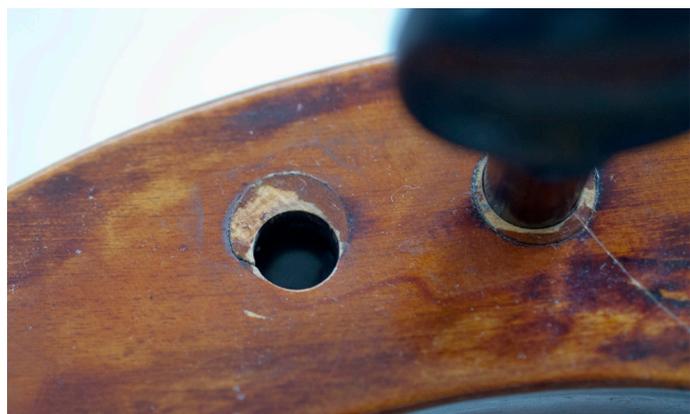
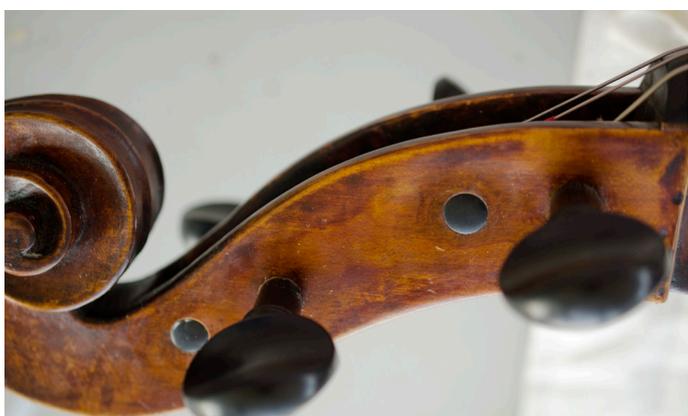
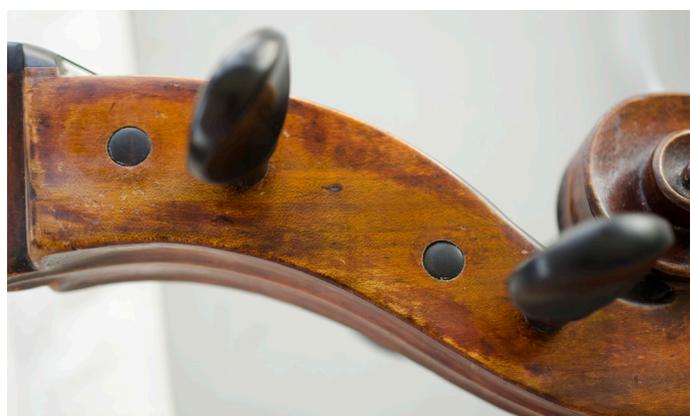
The pegholes are bushed several times and I have to replace them, and set new pegs.
