# Giovanni Grancino

## Violoncello Milano 1696

Restoration 2013-2014  
Julia van der Waerden

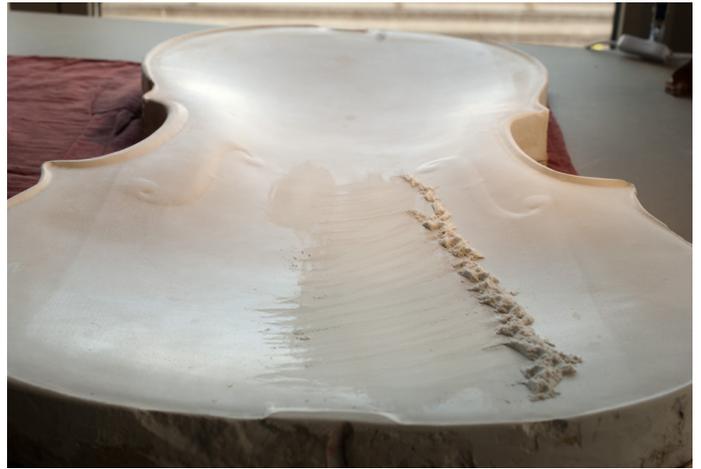
To even the distortion of the arching, the cast gets scraped.

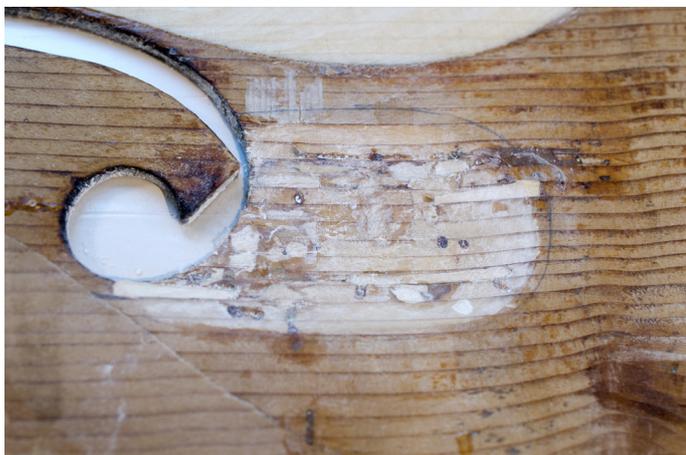
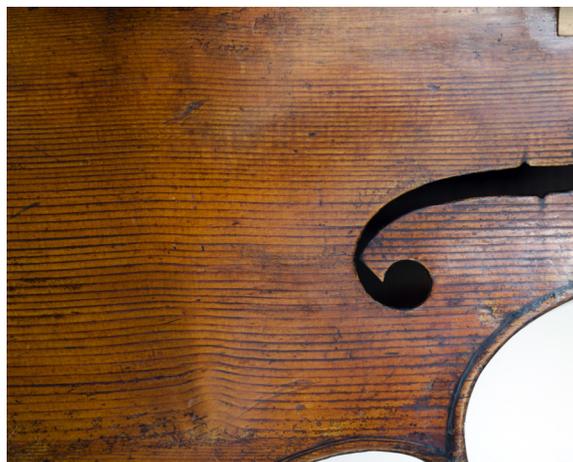
After all the patches are glued and thinned down roughly, I am mainly done with the woodwork of the top. To define the final thickness I use the old measurements as a guideline as well as the experience of holding many old tops and the feeling when you move them and test their flexibility. Also the sound it makes is useful to find the perfect thickness.

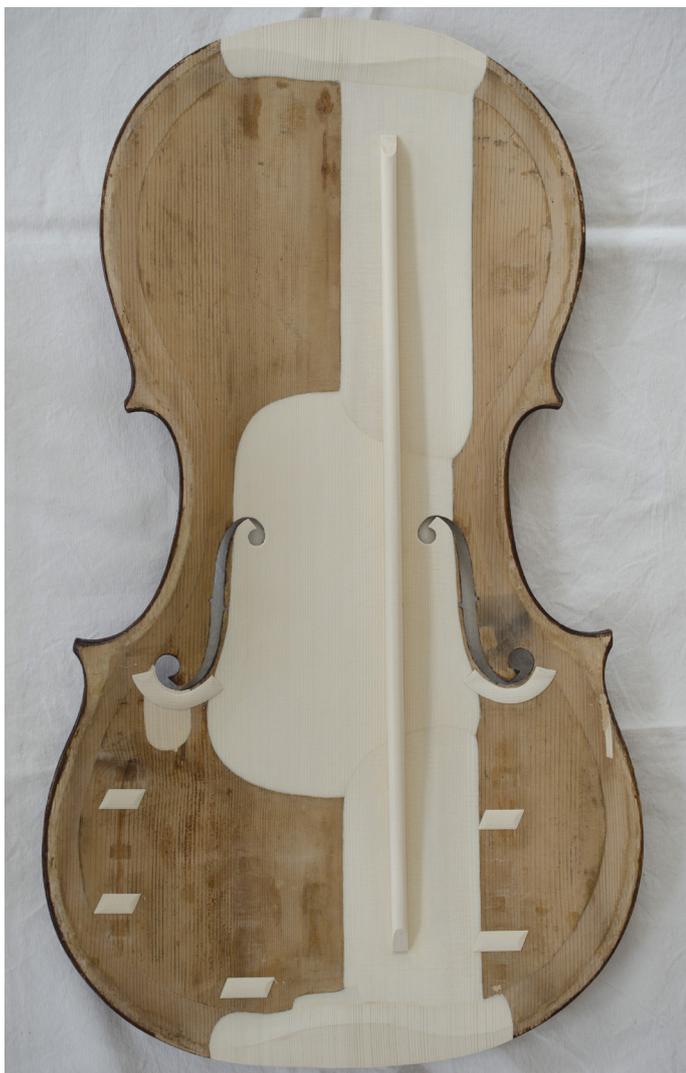
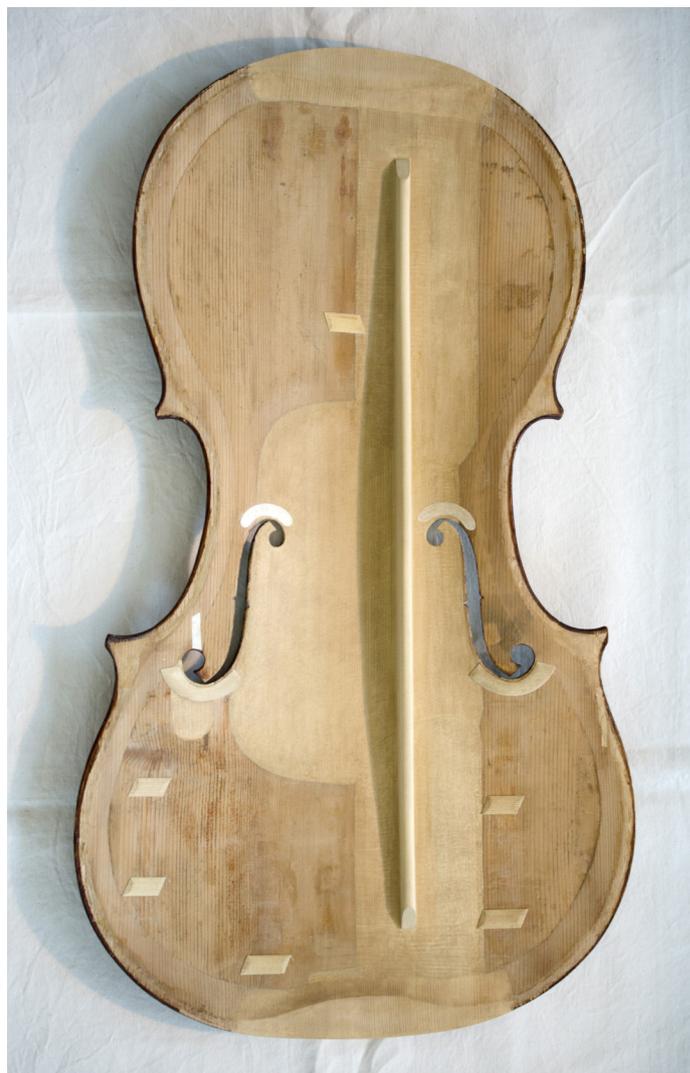
After all is finished, I put some color on the replaced wood from the inside of the instrument to make it look matching better to the original.

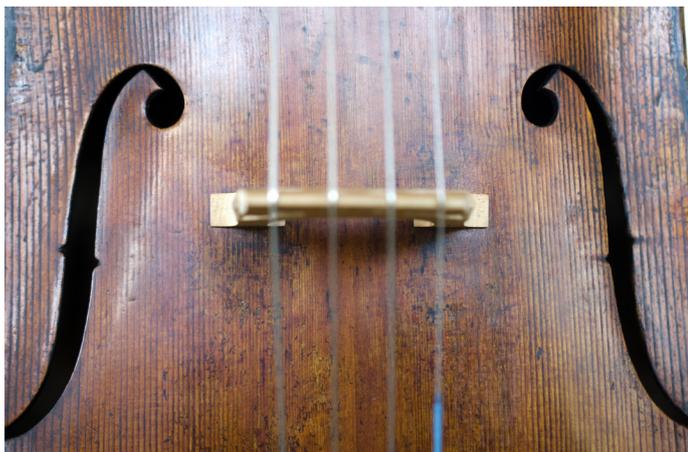
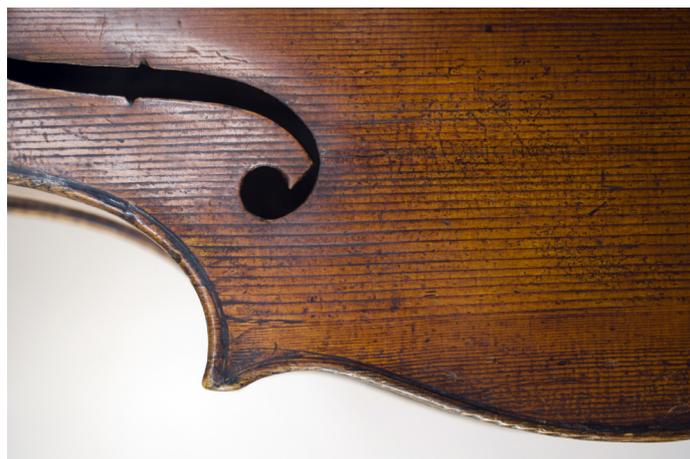
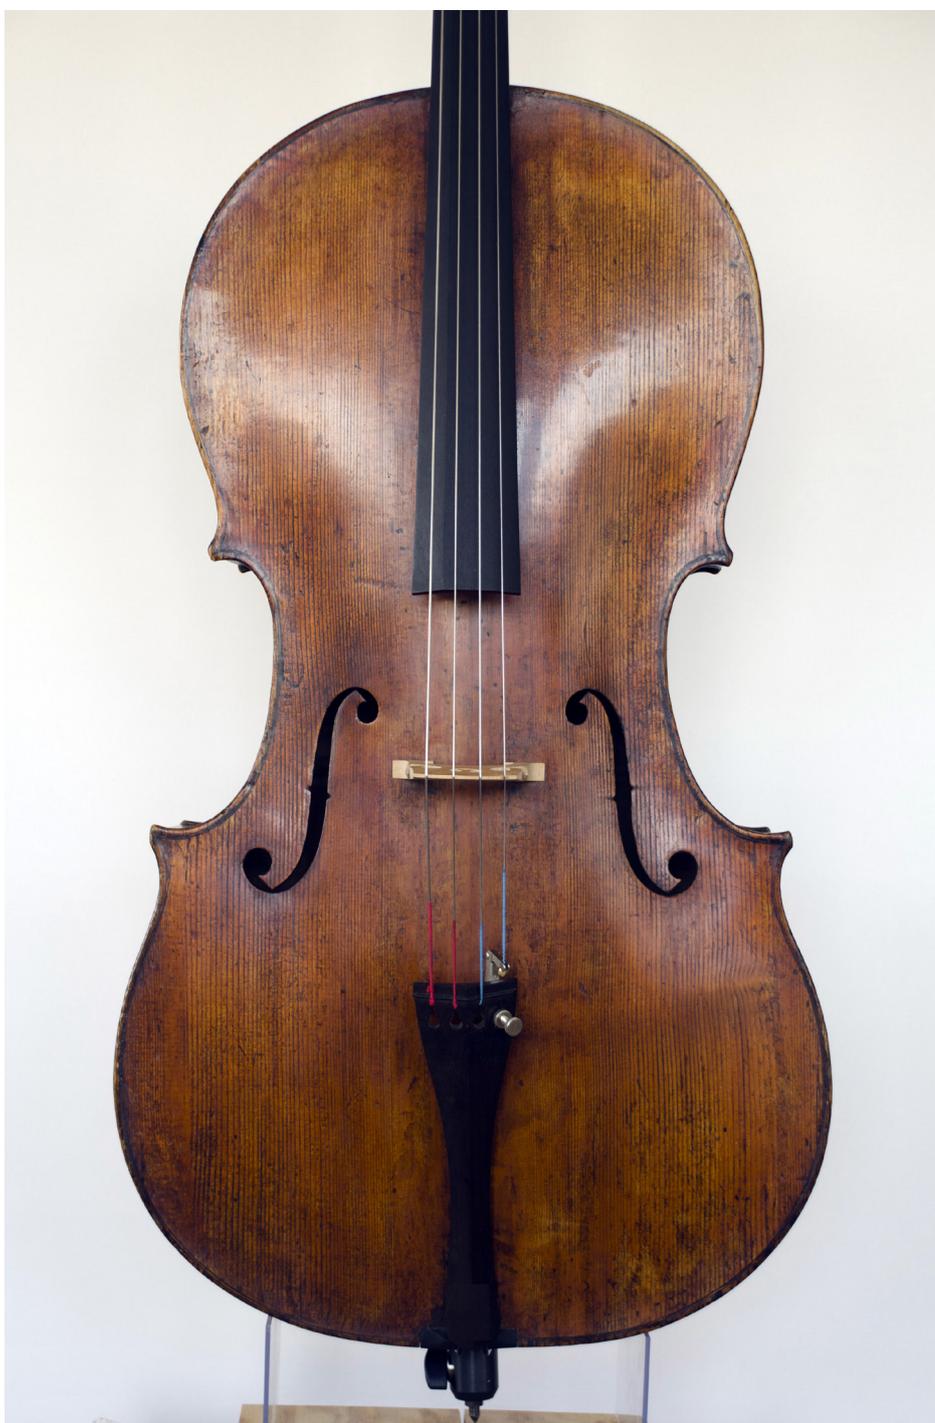
After closing the body, the whole top needs to be retouched.

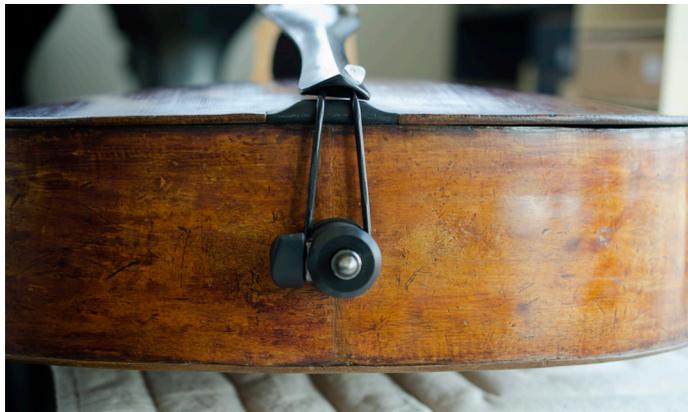
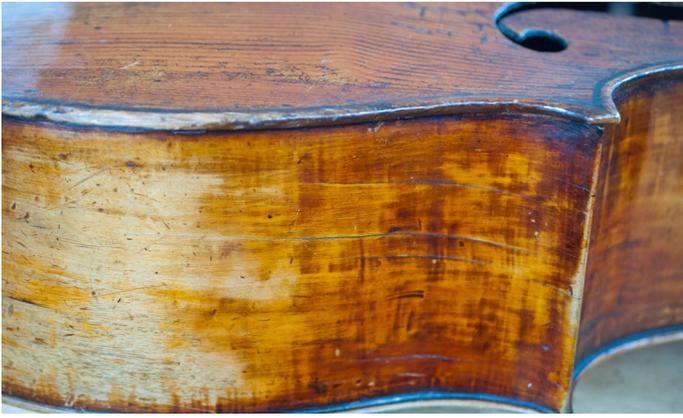
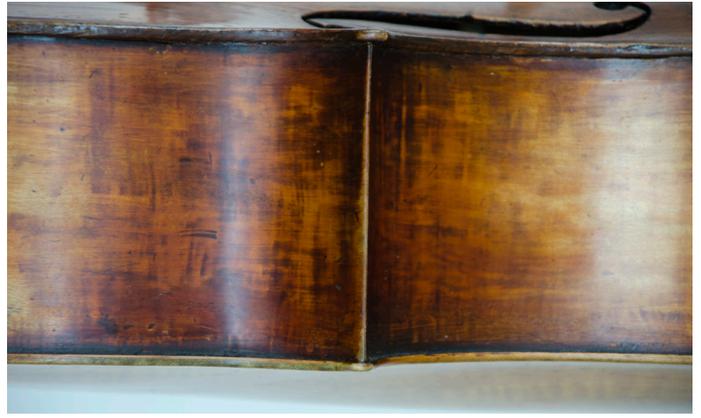
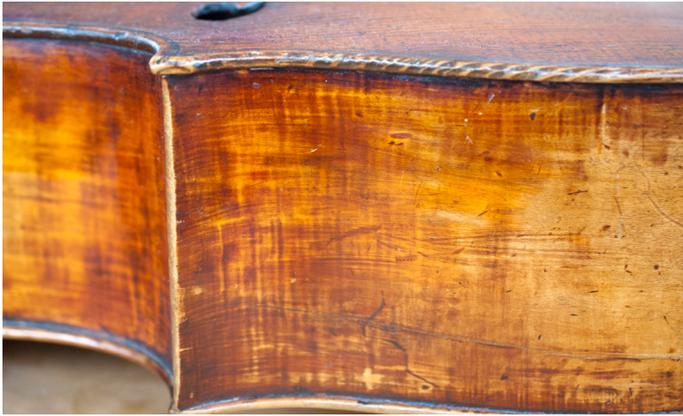
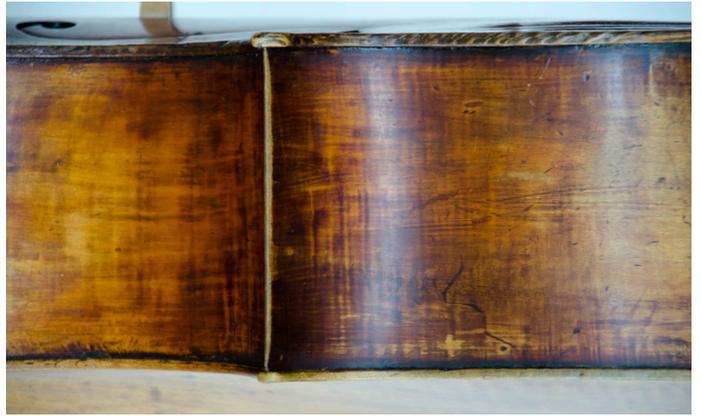
All the cracks need to be cleaned and glued properly. Often they are open, dirty and glued uneven. The old glue is hard to remove, because it is not the bone glue we usually use. Inside the cracks are held together with thick wooden patches, which are usually bad for the sound of an instrument.

Here some pictures from before and after the work:

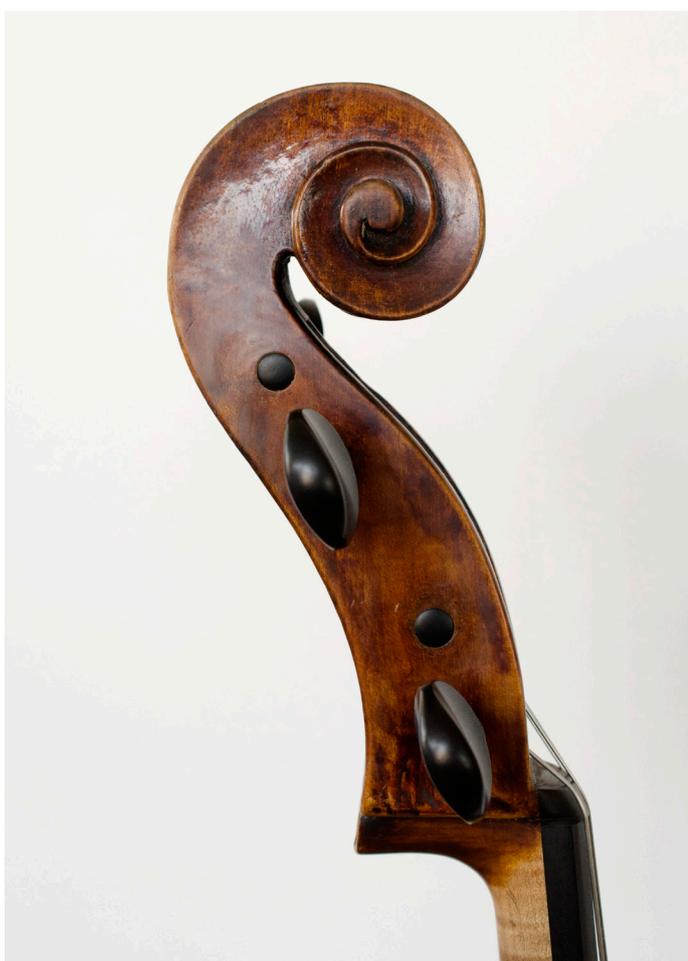
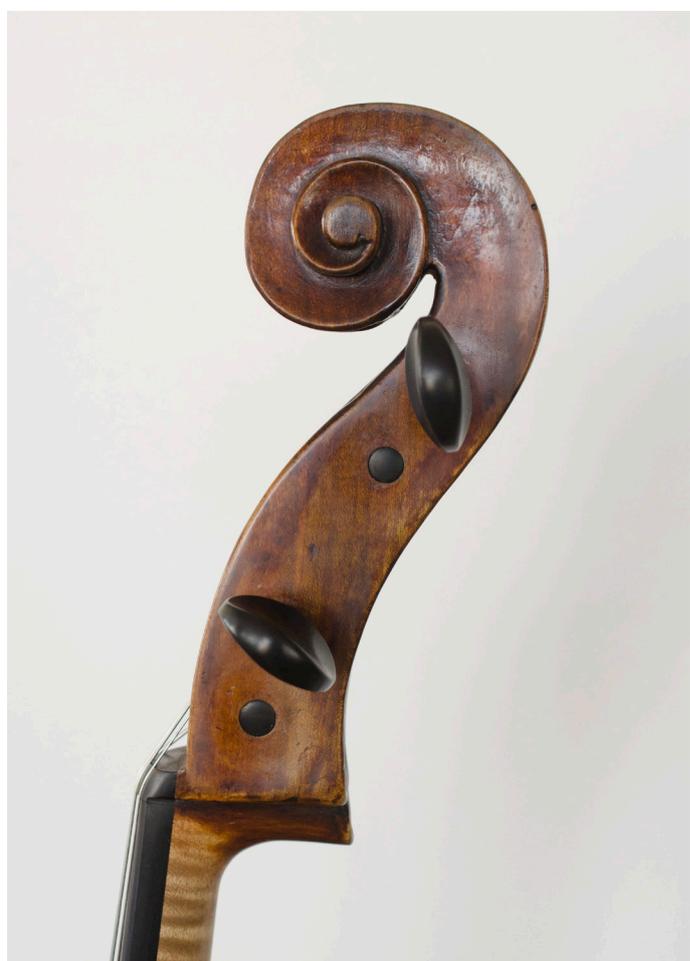
The pegholes are bushed several times and I have to replace them, and set new pegs.
